**An Appraisal Report of:
101 US Highway 24S
Chaffee County
Buena Vista, CO
81211**

Harold McCloud, MAI
Colorado Certified General Appraiser #CG1313633

February 4th, 2015

March 10th, 2015

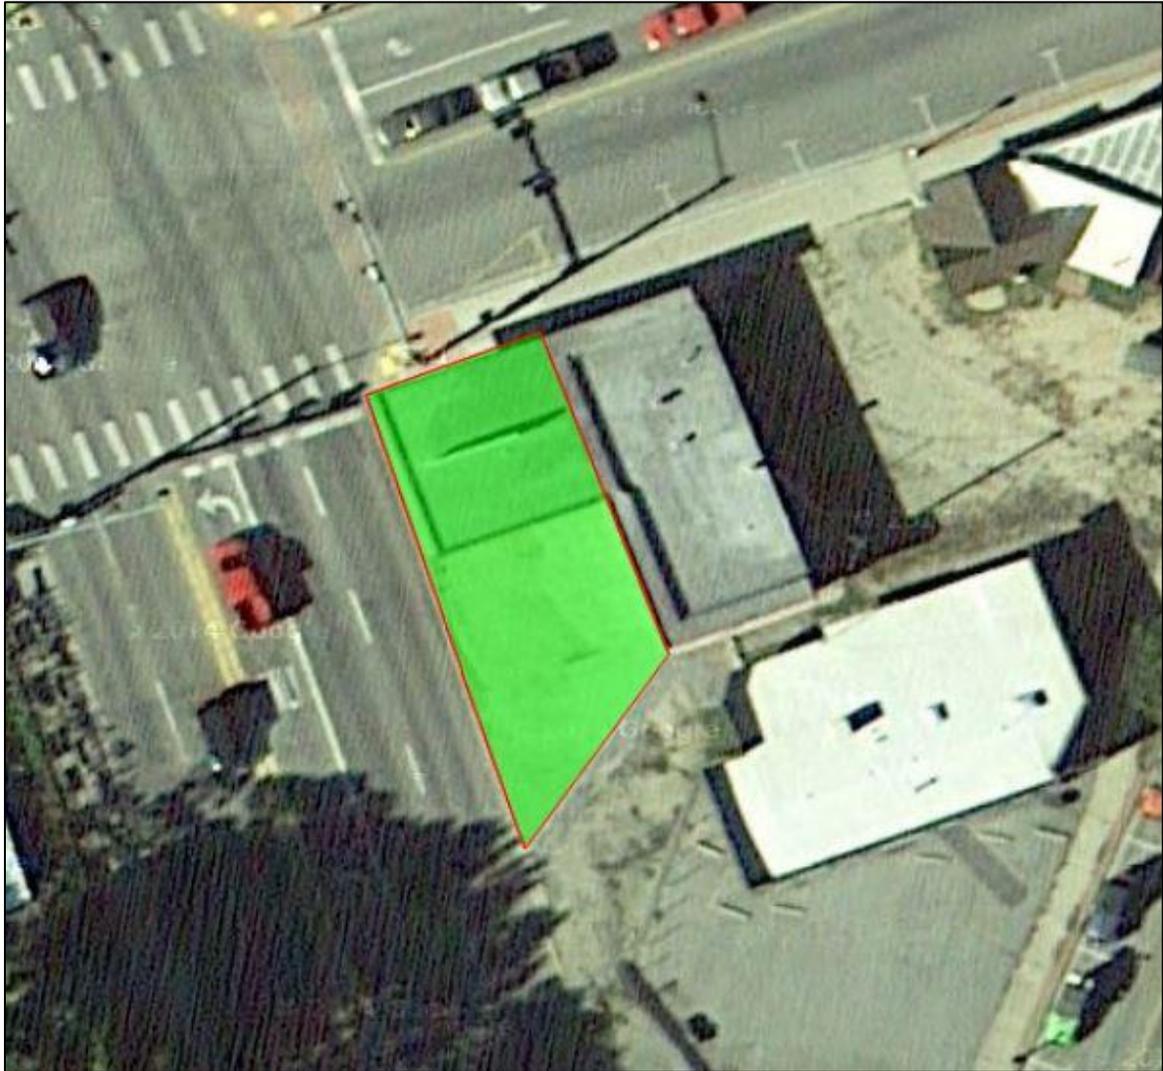
As shown in the photo provided on the following page, the subject site has concrete poured paved parking and driveways along the front of the current subject improvements. The site, including all parking spaces, driveways and ingress/egress points, is improved with +/-2,700 square feet of poured concrete paving, according to aerial measurements, which is considered to be in below market average condition but can be considered functional.

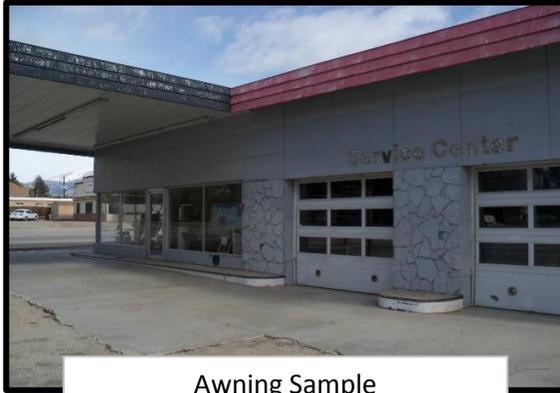
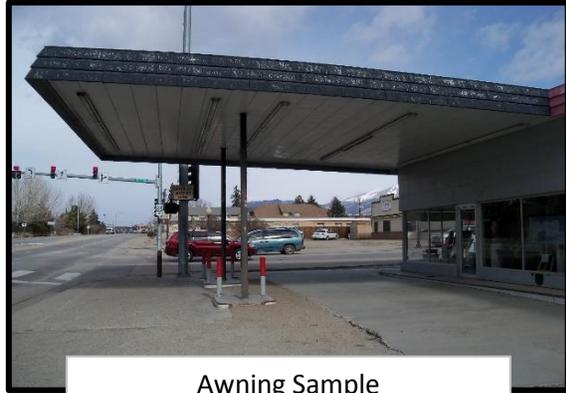
Awning Sample

As shown in the photos provided below the site is improved with a 31x33 covered awning attached to the current subject improvement. This awning covered the gas pumps that used to occupy the space under the awning. The awning provided shelter from the elements and provided lighting to patrons of the gas station when it was operational. The awning appears to be in average condition in its current state.

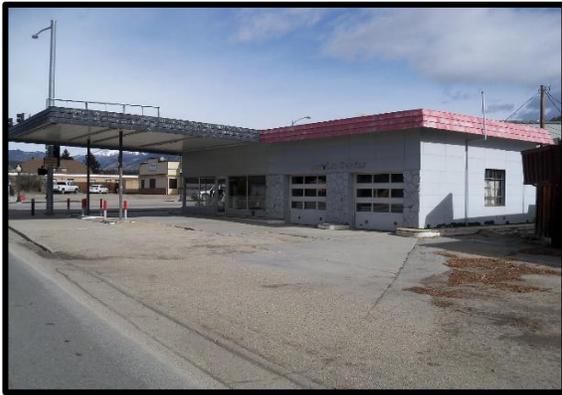
Subject Facing Northeast

A selection of exterior photos are provided on the following page to assist the reader in understanding the building style and components in place with regards to the subject property. A full catalog of subject photographs can be found in Exhibit B of this report.

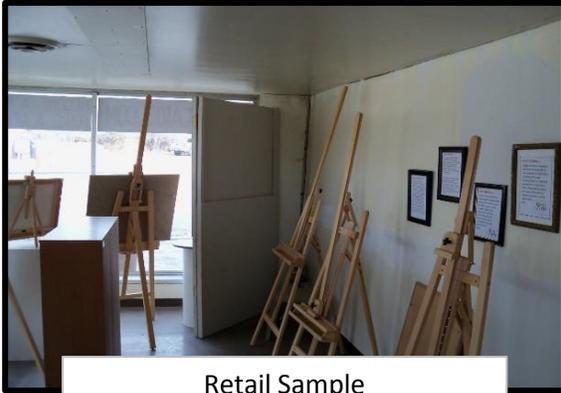
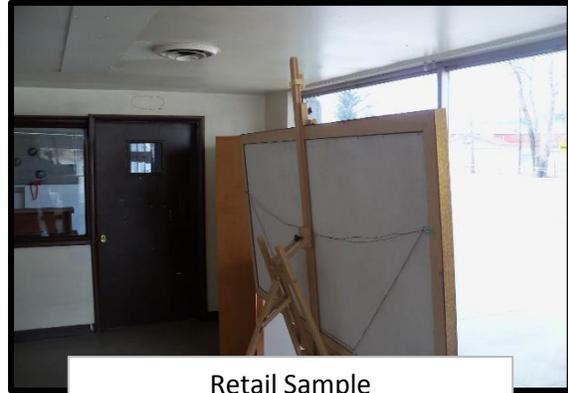
Retail Sample

<i>Walls</i>	Finished drywall with standard commercial baseboard in retail and office portions. Garage area has painted concrete block walls.
<i>Flooring</i>	Commercial Vinyl Tile in retail portion. Exposed concrete floors in garage and office area.
<i>Ceiling System</i>	Finished Drywall
<i>Doors</i>	Standard commercial grade. Typical.
<i>Lighting</i>	Lighting has been removed except for a halogen fixture in the office portion of the building. Site appears to have had fluorescent fixtures in the past.
<i>Restrooms</i>	Standard commercial grade restrooms. Adequate and typical.

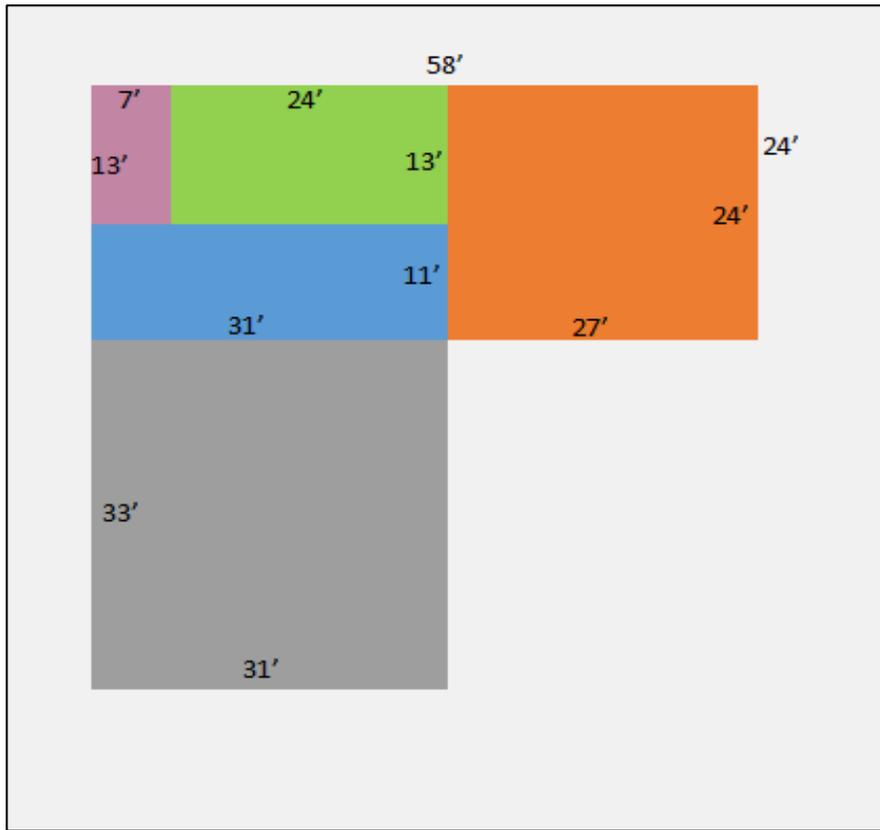
Below is a building sketch based on on-site measurements by the appraiser. Sketch is not to scale and is provided for reference. All measurements provided on the sketch are considered true and accurate.

Covered Awning
	2 Bay Shop w 12 ft. ceiling heights
	Store
	Office
	Restrooms
